AITKIN PUBLIC SCHOOLS

ASSESSMENT REPORT:

Parking Lots, Sidewalks and Athletic Fields

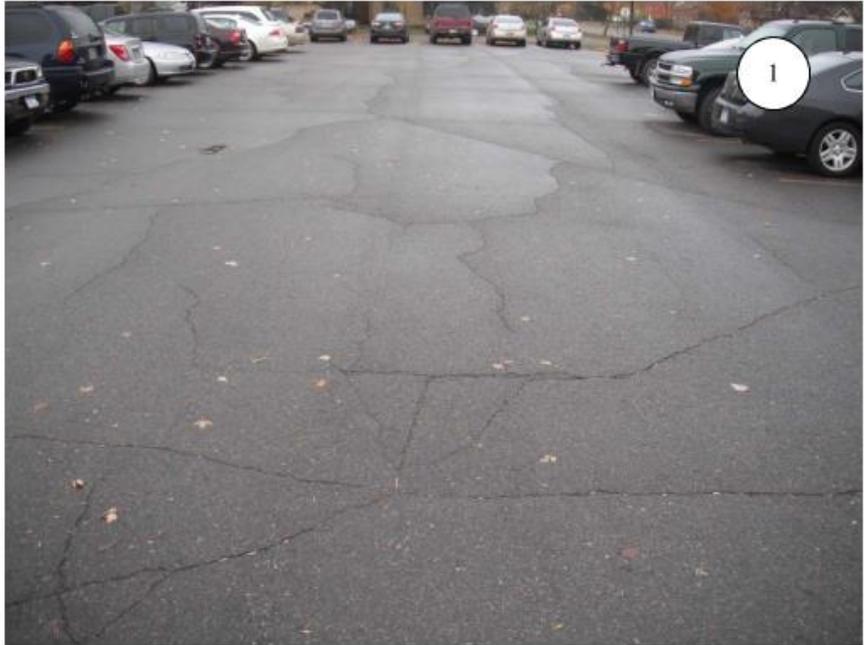
Northwest Parking Lot – The existing asphalt parking lot is relatively old and exhibits large amounts of cracking but is still structurally sound and no significant areas of damaged pavement were observed (photo 1). Recommend crack sealing and seal coating this parking lot in 2016 at an estimated construction cost of \$7,550.

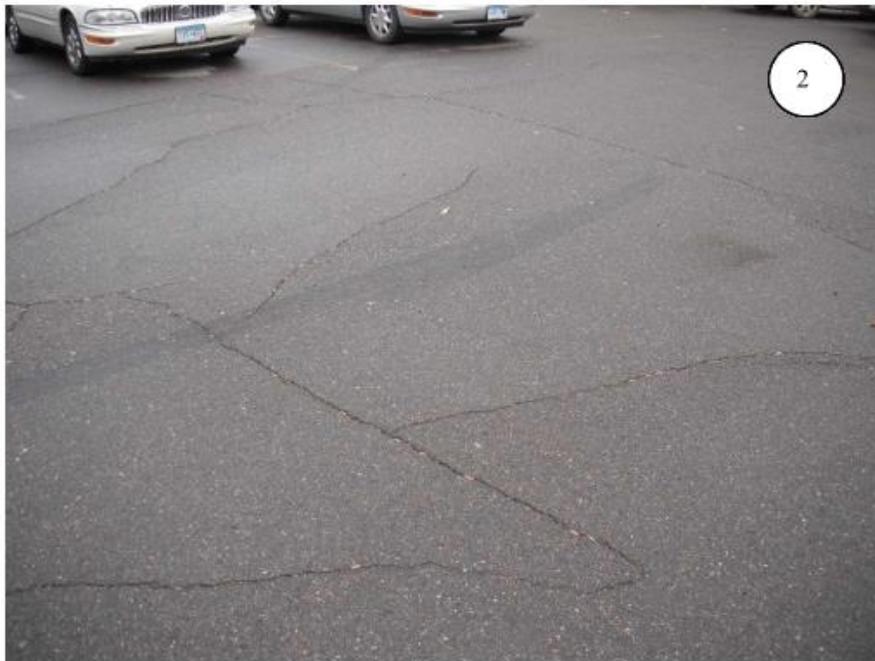
North Parking Lot – The existing asphalt parking lot is relatively old and exhibits large amounts of cracking but is still structurally sound and no significant areas of damaged pavement were observed (photo 2). Recommend crack sealing and seal coating this parking lot in 2016 at an estimated construction cost of \$7,550.

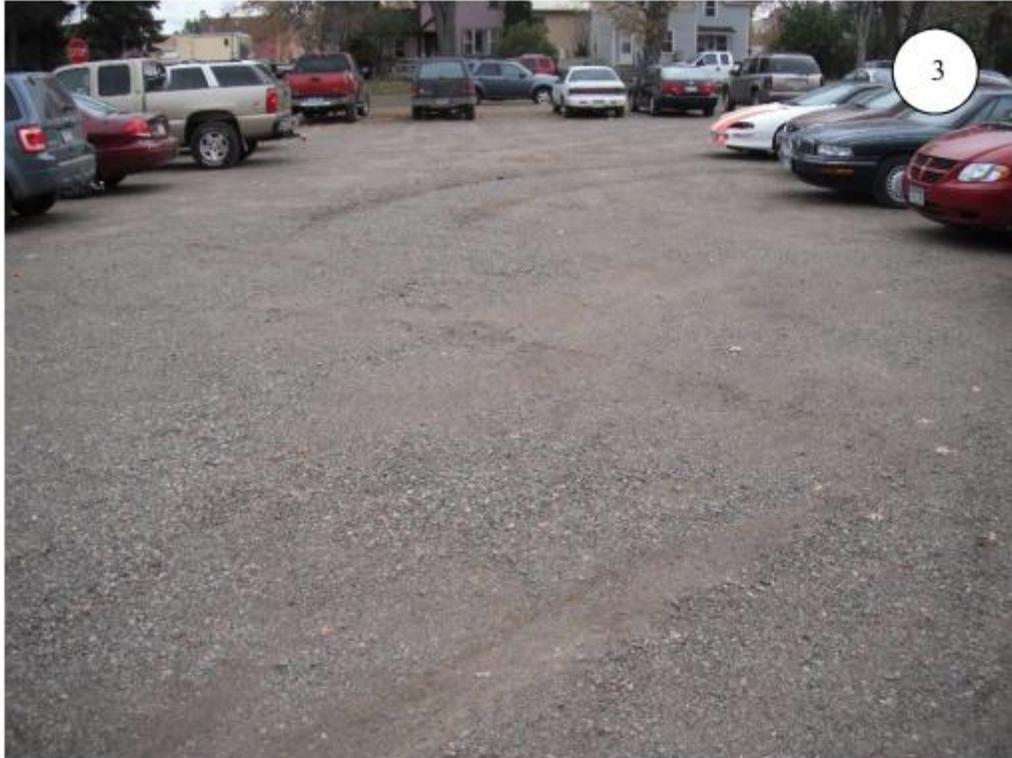
Northeast Parking Lot – This parking area is currently gravel surfaced (photo 3). Recommend constructing a new asphalt parking lot at an estimated construction cost of approximately \$125,760.

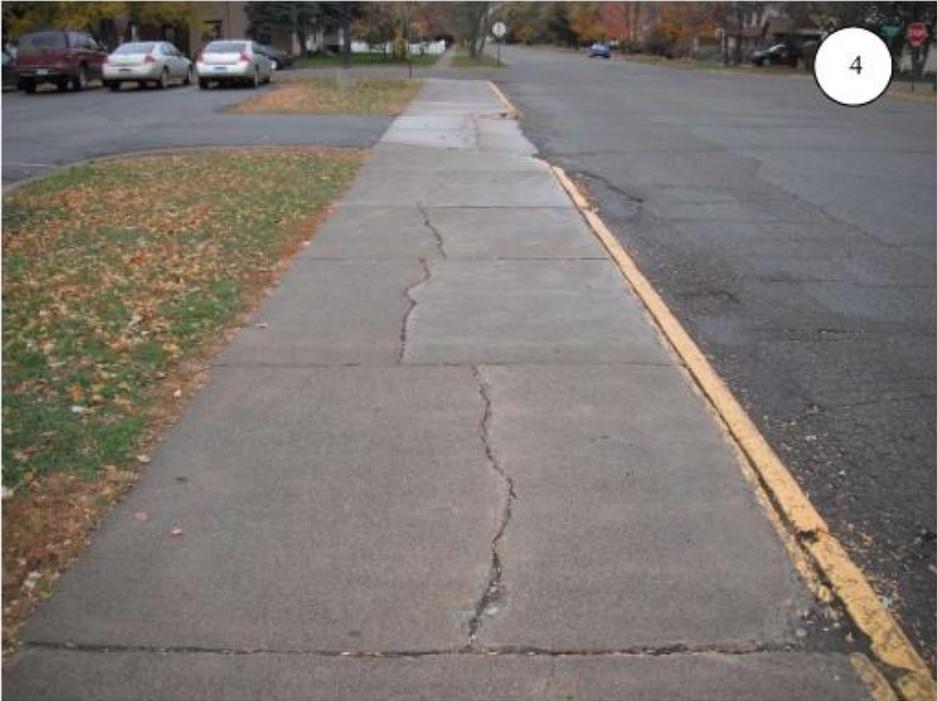
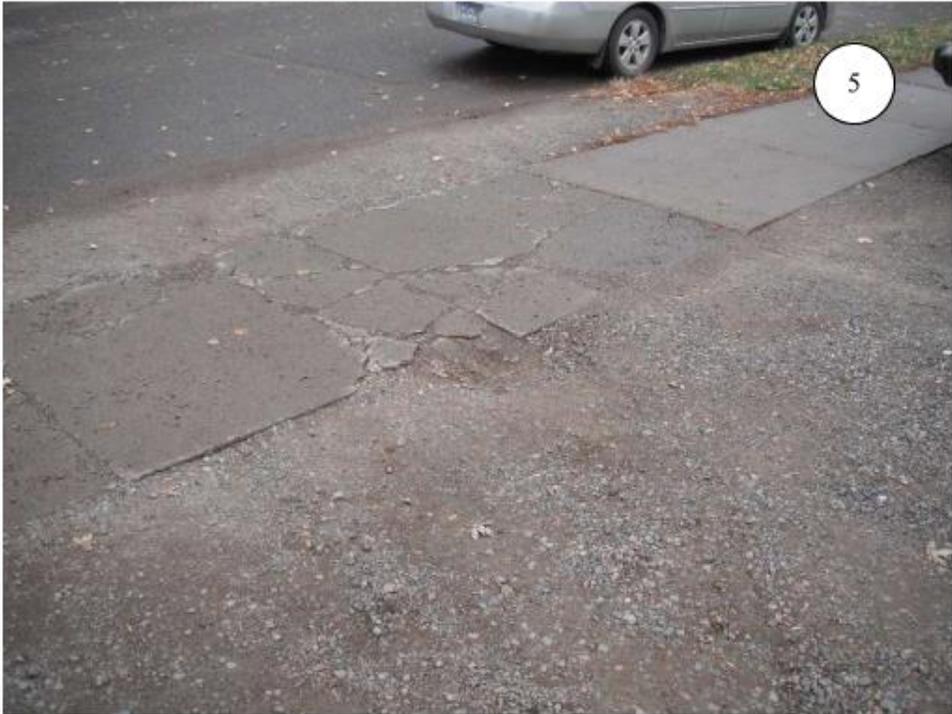
Concrete sidewalks – The majority of the concrete sidewalks at the site are in good overall condition, but several areas of damaged sidewalk were observed (photos 4 & 5). Recommend replacing these several areas of damaged concrete sidewalk at an estimated construction cost of approximately \$17,610.

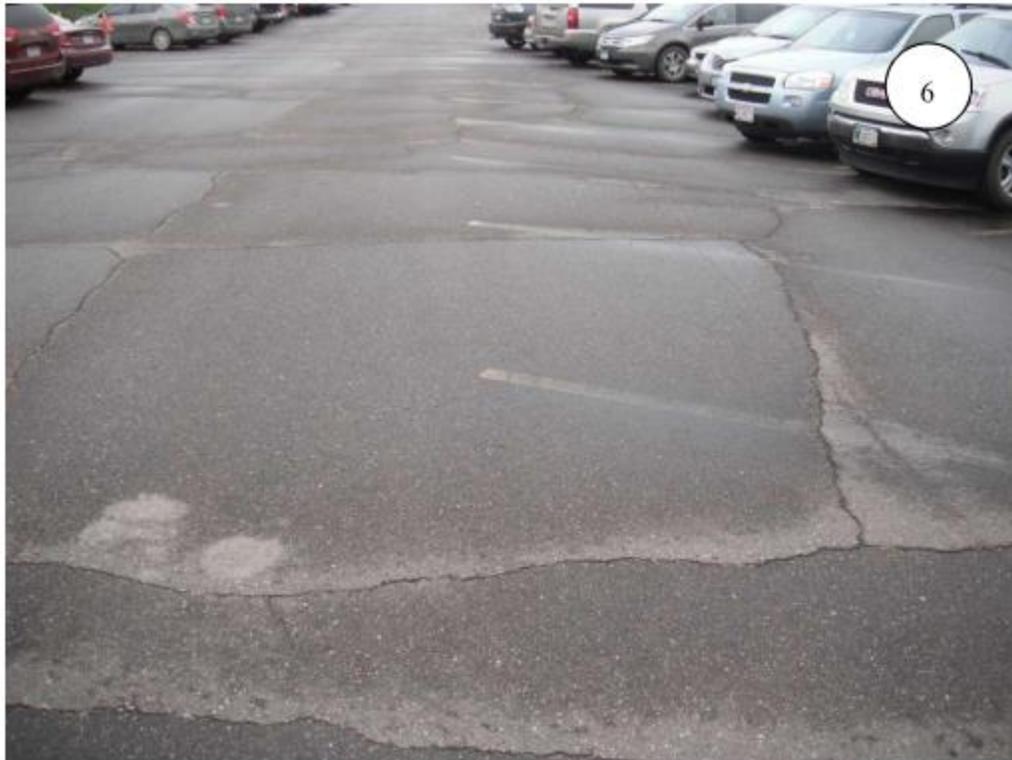
North Parking Lot – This asphalt parking lot is in good overall condition. The parking lot exhibits large amounts of cracking (photo 6). The western portion of the parking lot appears to be newer and does not contain as much cracking (photo 7). Some small areas of damaged pavement were observed, though the damage was not yet very severe (photo 8). Recommend repairing the small damaged areas, and crack sealing and seal coating this parking lot in 2017 (or in 2016 along with the seal coating at the High School) at an estimated construction cost of approximately \$15,100.

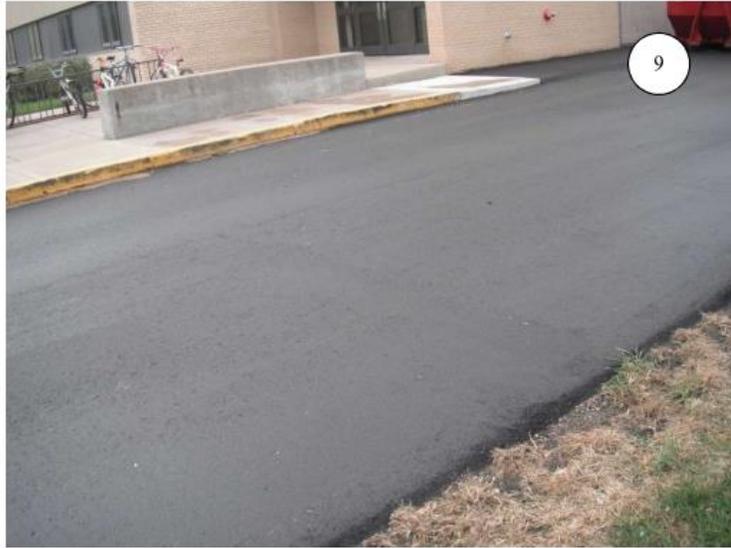
North Loading Dock Drive – This asphalt area is very new, in excellent condition, and requires no maintenance in the next five years (photo 9)

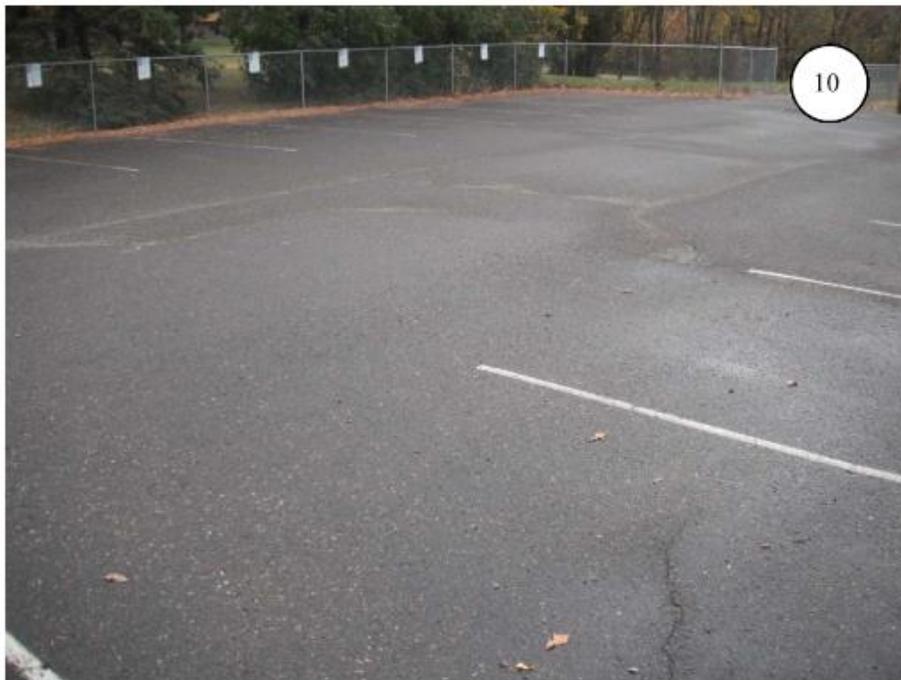
Southeast Parking Lot – This asphalt parking lot is in fair condition, with a very weathered and rough surface and some relatively small areas of damaged pavement (photo 10). Recommend repairing the damaged pavement areas in 2016 at an estimated cost of approximately \$2,520 and then installing a new 2" overlay over the entire parking lot in 2017 or 2018 at an estimated construction cost of approximately \$12,580.

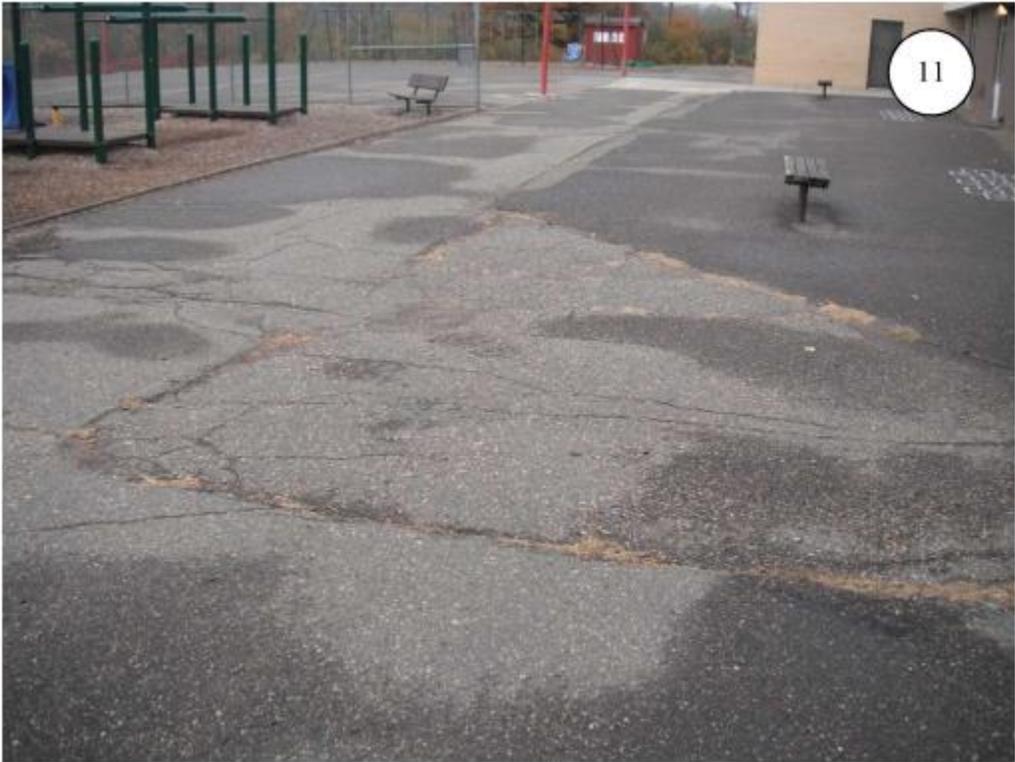
South Playground – The South Playground is an asphalt pavement in poor to fair condition, exhibiting significant cracking, a very weathered surface, and some larger areas of damaged pavement (photo 11). Recommend repairing the damaged pavement areas in 2016 and then overlaying the playground with 2” of new asphalt pavement in 2017 or 2018 (at the same time the Southeast Parking Lot overlay occurs) at an estimated construction cost of approximately \$13,840.

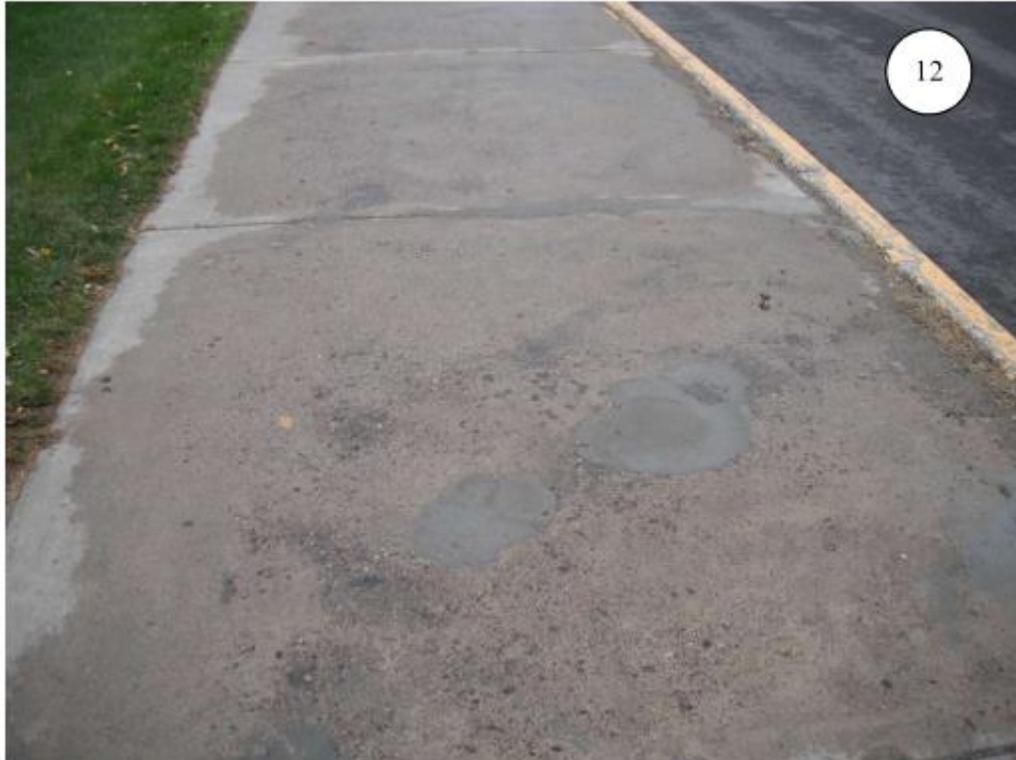
Concrete Sidewalks – The concrete sidewalks are in very good condition overall, except for areas of the sidewalk near the northeast corner of the school. Several previous patches were observed (photo 12). These damaged and patched sections of the sidewalk should be replaced at an estimated construction cost of approximately \$12,580.

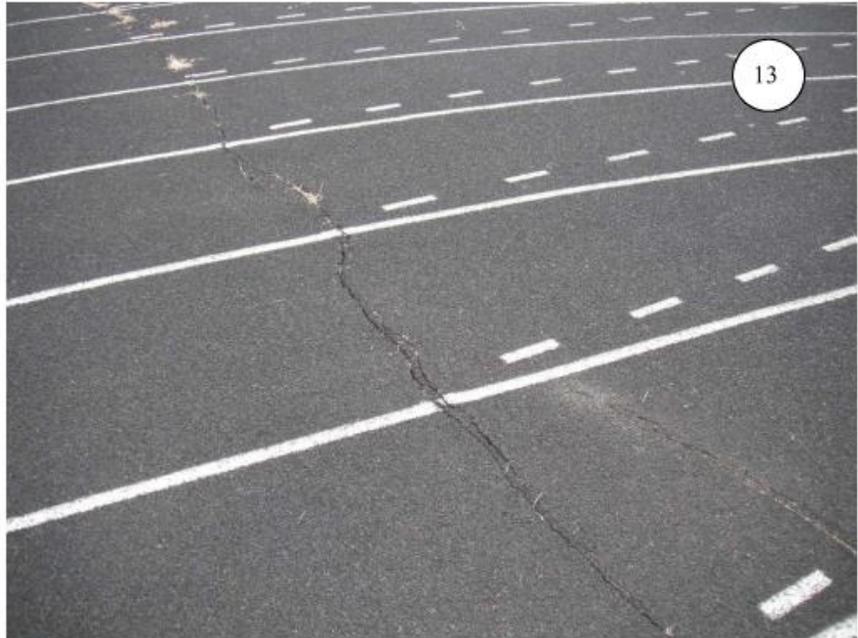
Athletic Track – The outdoor athletic track is in poor condition, with significant cracking present and a thin and relatively hard rubber surface (photo 13). Recommend reconstructing the athletic track and field event areas at an estimated construction cost of approximately \$600,000 to \$700,000 for a new 8' lane polyurethane all-weather track and amenities.

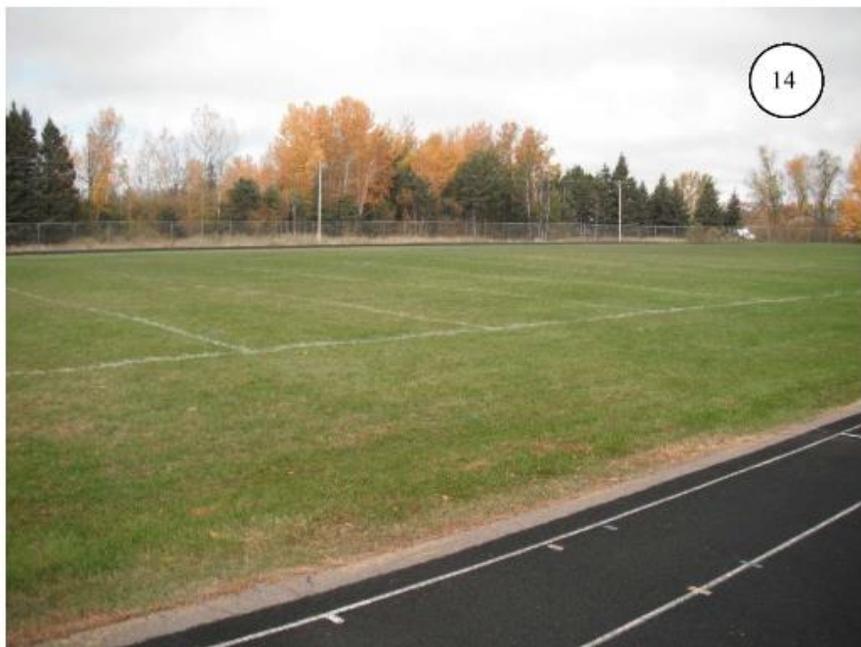
Practice Football Field – The practice football field is in fair condition, lacking an irrigation system and proper drainage (photo 14). Recommend replacing this football field with a new sand cap type of field where approximately 2" – 5" of the existing top soil layer is removed and replaced with 5" – 6" of specifically blended high sand-based root zone soil. An extensive drain tile system is installed below the field to provide proper sub-surface drainage and a new irrigation system would also be installed. The entire field is then seeded, not sodded. The new practice football field would cost approximately \$250,000 - \$300,000.

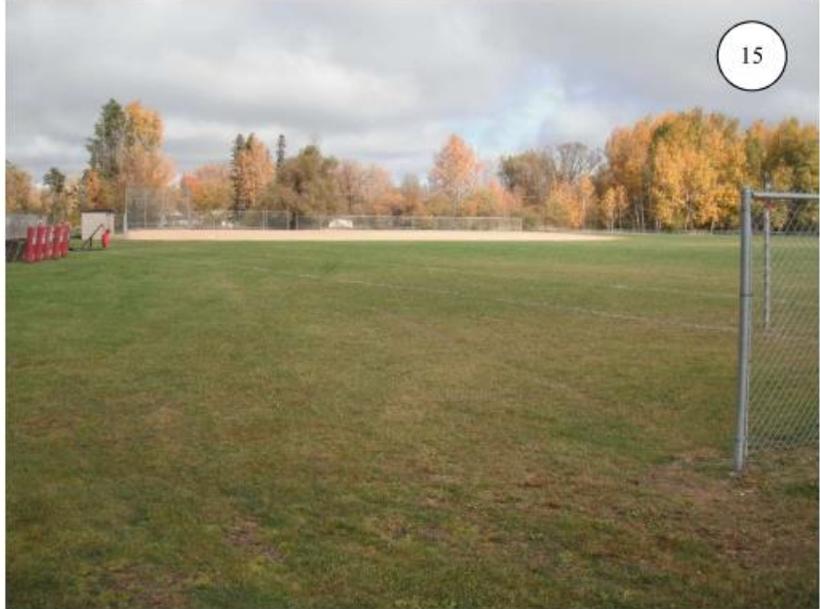
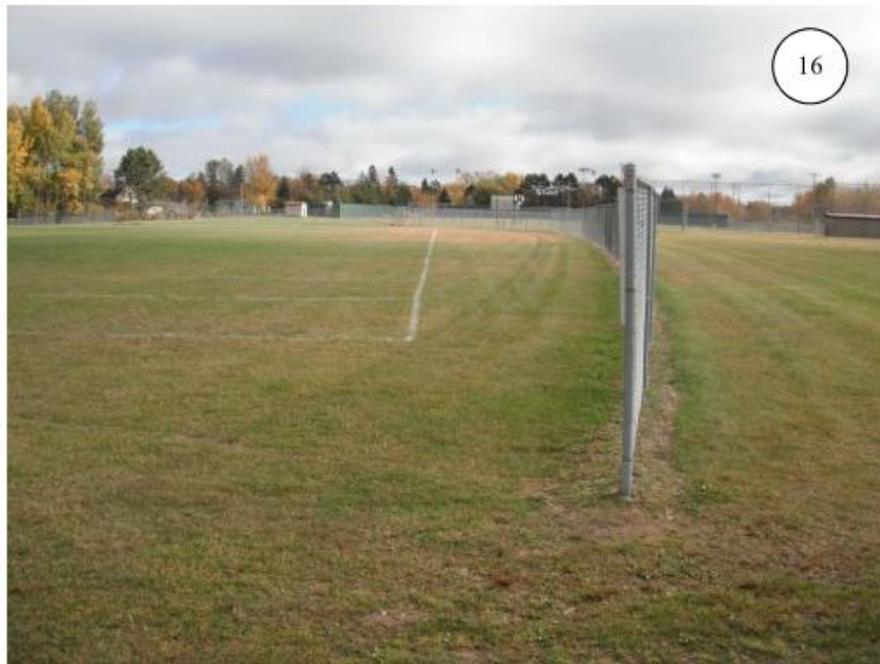
West Baseball Field, Softball Field and East Baseball Field – These fields are in fair condition but lack irrigation systems and proper drainage (photos 15 and 16). Recommend replacing these fields with new Sand Cap field system in addition to new irrigation and sub-surface drain tile system. The estimated construction cost to replace these fields including fencing and backstops would be approximately:

West Baseball Field:
\$250,000 - \$300,000

Softball Field:
\$200,000 – \$250,000

East Baseball Field:
\$250,000 - \$300,000

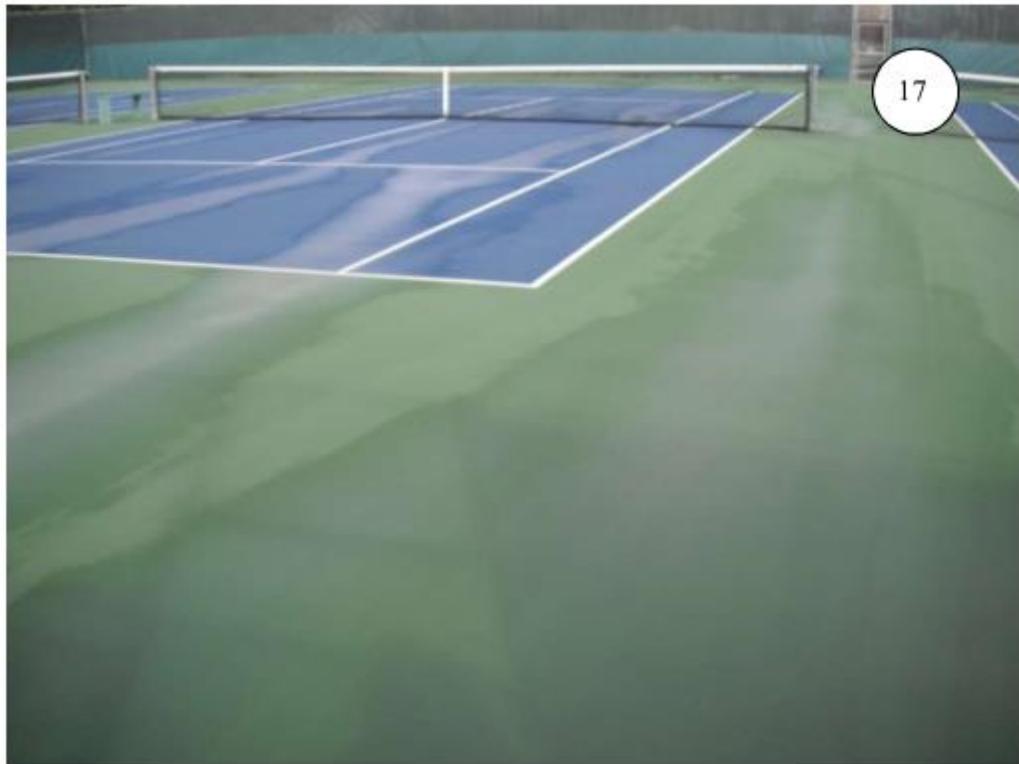
Tennis Courts – The five tennis courts are in excellent condition other than some minor ponding areas and slightly worn color surface (photo 17). Recommend color coating these five courts in 2017 or 2018 at an estimated construction cost of approximately \$20,000 - \$25,000.

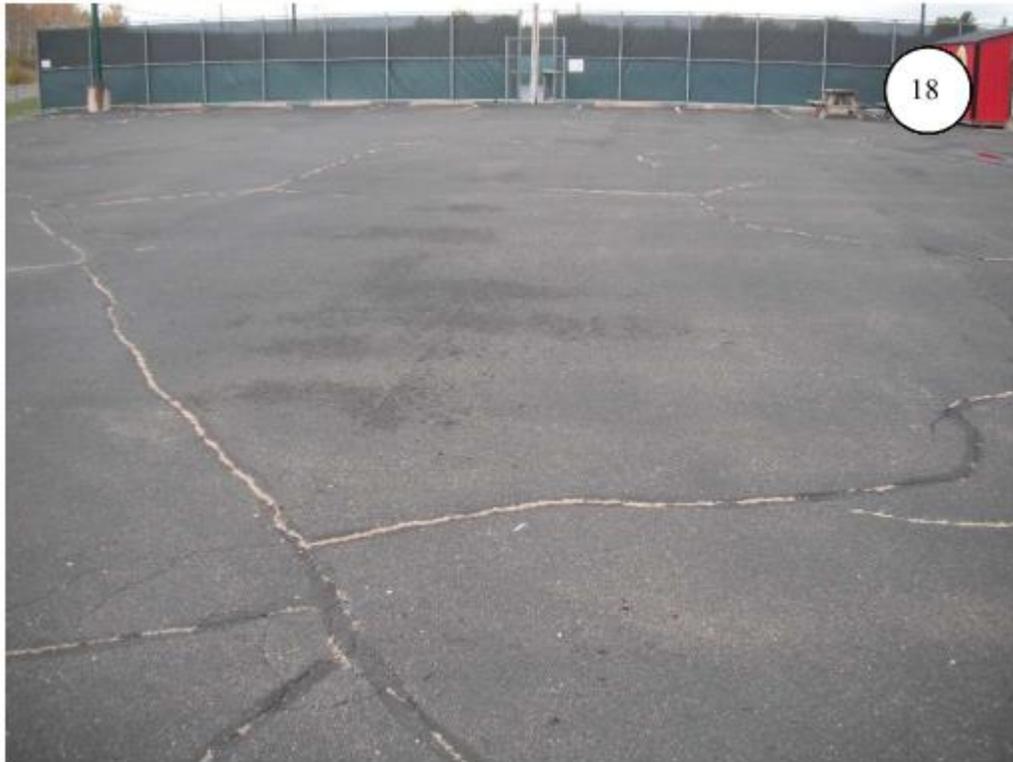
Tennis Parking Lot – The tennis court parking lot is in good overall condition, exhibiting significant amounts of cracking (photo 18). This asphalt parking area has been seal coated previously, and approximately 50% of that seal coat material has worn off. Recommend crack sealing and seal coating this parking lot in 2016 or 2017 at an estimated construction cost of approximately \$7,550.

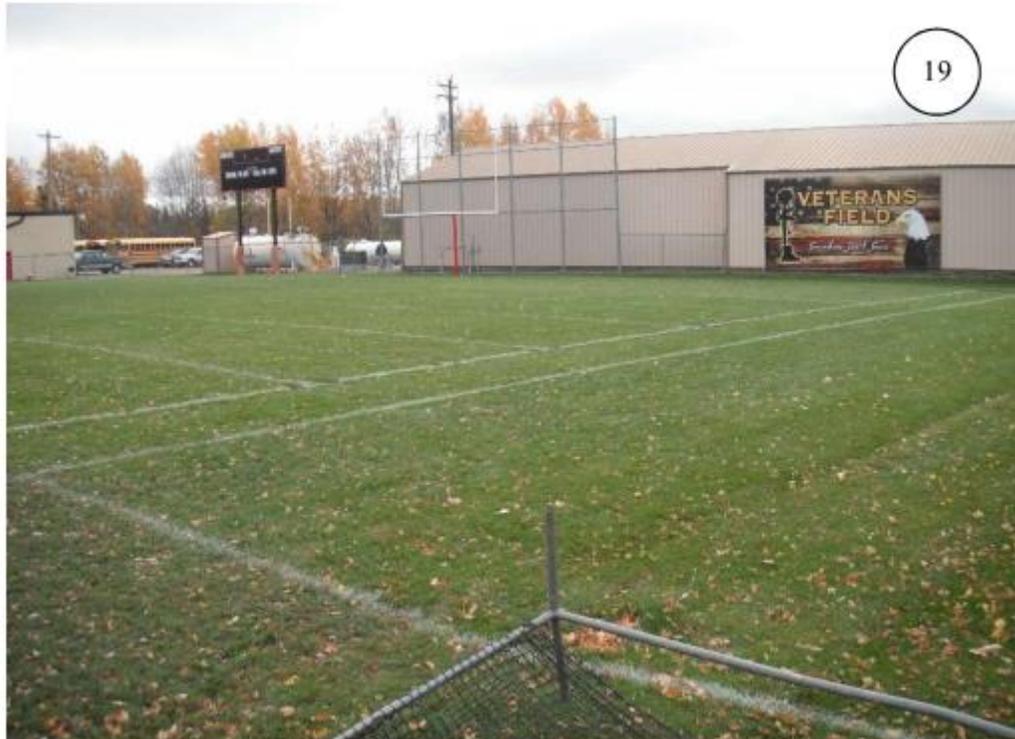
Varsity Football Field – The varsity football field is in fair condition, lacking an irrigation system and proper drainage (photo 19). Recommend replacing this football field with a new sand cap type of field where approximately 2” – 5” of the existing top soil layer is removed and replaced with 5” – 6” of specifically blended high sand-based root zone soil. An extensive drain tile system is installed below the field to provide proper sub-surface drainage and a new irrigation system would also be installed. The entire field is then seeded, not sodded. The new football field would cost approximately \$300,000 - \$350,000.

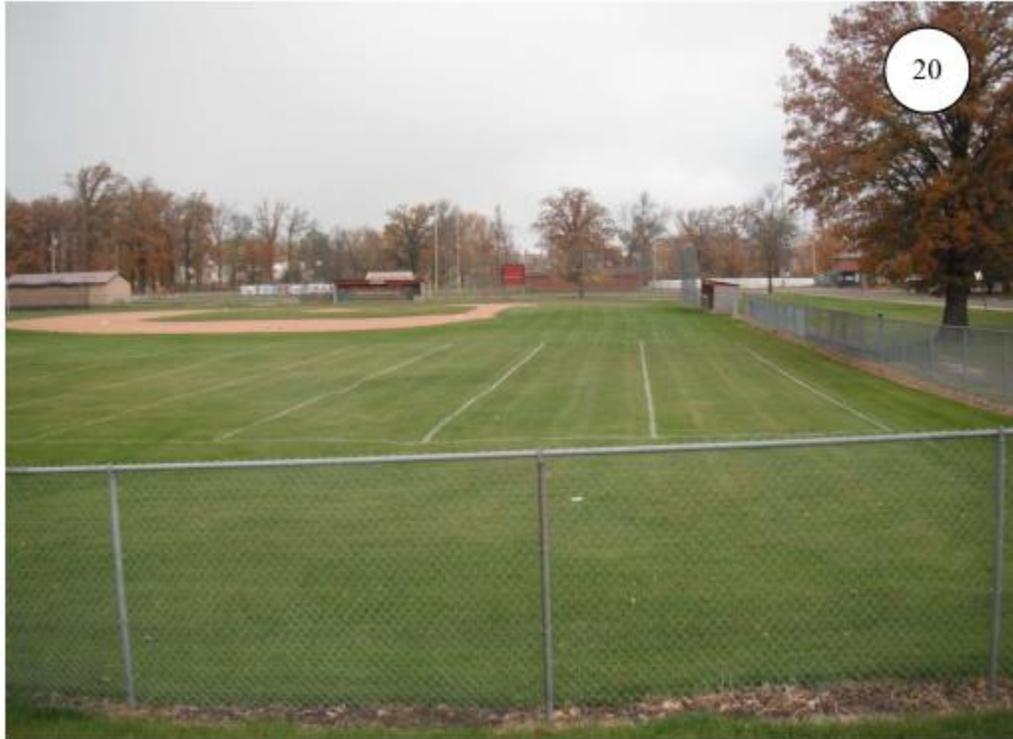
Varsity Baseball Field – This field is in fair condition but lacks an irrigation system and proper drainage (photo 20). Recommend replacing this field with new Sand Cap field system in addition to new irrigation and sub-surface drain tile system. The estimated construction cost to replace the field including fencing and backstops would be approximately \$300,000 - \$350,000.
